**Location:** North Sea  
**Customer:** UK Operator  
**Well Type:** Producer (65 degrees deviation)

**Case Study** Fishing

## eCutter Cuts 0.125-in Wire at Depth to Enable Retrieval of Stuck Toolstring in High-Deviation Wellbore

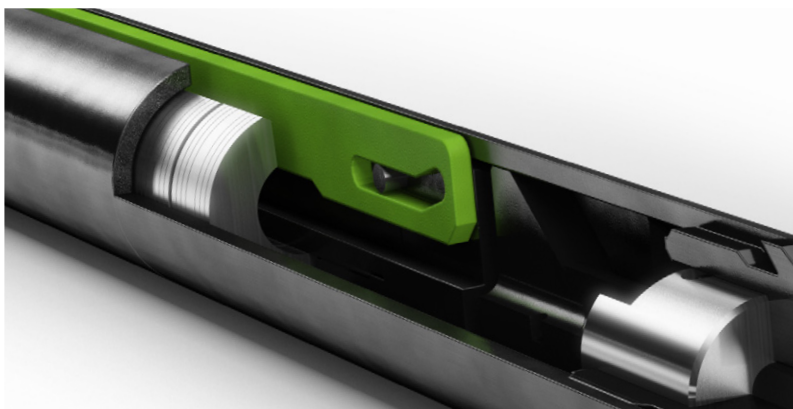
▲ Peak eCutter

After careful review of the well design and discussion with the customer, the preferred option for cable release was to deploy the 2.2-in Peak eCutter and Pump Down Go-Devil assembly with 3.065-in swab cups to ensure the cutter reached the correct depth and cut at the rope socket, which was located at 65 degrees of deviation.

enabling the Peak eCutter to reach the required cutting depth of 2,349 m (93 degrees C; 1,600 psi). After six hours, the Peak eCutter was activated and successfully cut the wire at the rope socket, whilst at the same time gripping the severed wire.

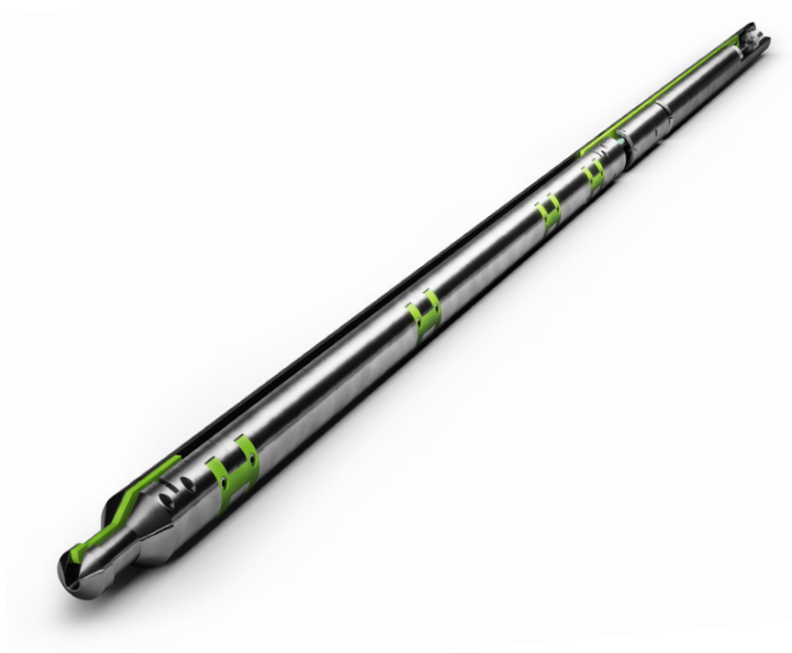
▲ Peak eCutter
