Location: Maari Field,
New Zealand

Case Study

Wellbore Cleanup and Debris Removal

Recovery of Magnetic Junk in High-Temperature Wells

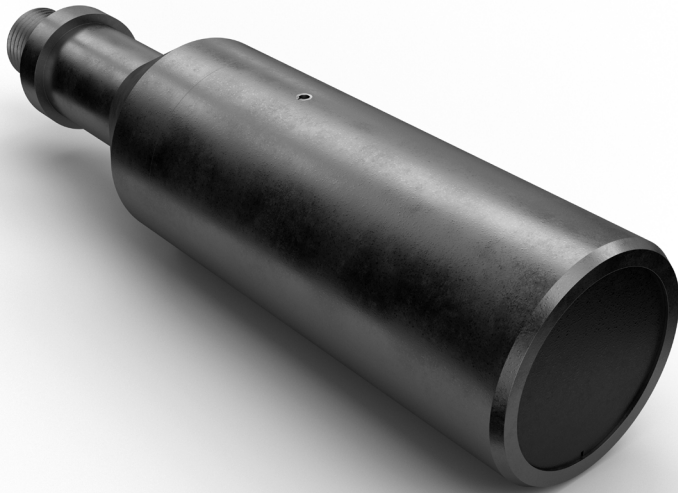
managed to recover the clamp pieces in five tractor runs on e-line and, due to the powerful strength of the Peak Magnet, even retrieved two blocks and allen key bolts lost from an earlier clamp.

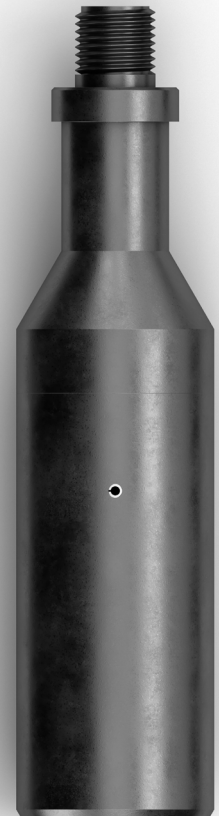
▲ High Temperature / High Strength Magnet

Compared to other magnets available on the market, Peak's High Temperature/High Strength Magnet is particularly strong and can withstand prolonged exposure to very high downhole temperatures (500 deg F) without losing magnetic strength.

Peak's High Temperature/High Strength Magnet is available in a range of sizes (1.75-in up to 4.5-in OD) to suit the application and well geometry.
